Manhole Inspection Summary

Manhole # S35Y1_019MH

Insp Date: **4/18/08 1:30 PM**

Location Address: **18 Jeffrey-Bristol**

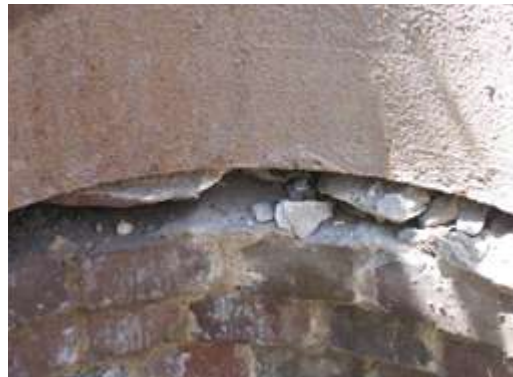
Defect 3

Condition: ☐ Sound ☐ Cracked ☐ Root Intrusion ☒ **Loose Brick** ☐ Deteriorated

Loose bricks

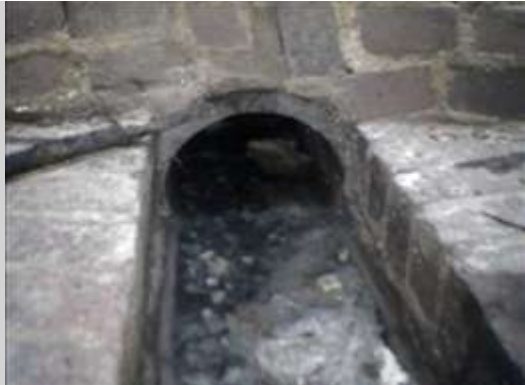
12 O'Clock Outflow

Pipe Height: **8.4** (in.) Rod and Bar (Angled)
Pipe Material: **Clay** ☐ Pipe Lined
Invert Depth: **8.50** (ft.) Flow Characteristics: **Slow**
Deposits: ☐ None ☒ **Mud** ☒ **Sludge** ☒ **Debris** ☐ Grease
Silt Depth: **3** (in.) Deposits Extent: **Medium**
Infiltration: **None** Pipe Seal Cond: **Sound**

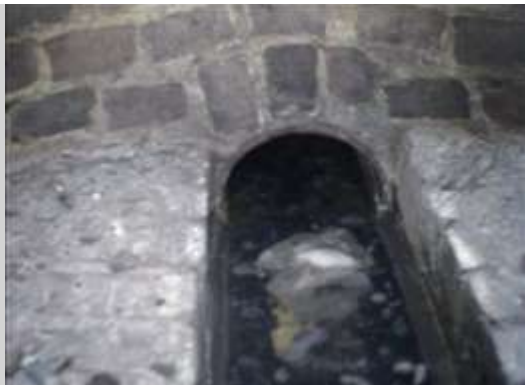
6 O'Clock Inflow

Pipe Height: **8.4** (in.) Rod and Bar (Angled)
Pipe Material: **Clay** ☐ Pipe Lined
Invert Depth: **8.42** (ft.) Flow Characteristics: **Slow**
Deposits: ☐ None ☒ **Mud** ☒ **Sludge** ☒ **Debris** ☐ Grease
Silt Depth: **3** (in.) Deposits Extent: **Medium**
Infiltration: **None** Pipe Seal Cond: **Sound**
